A Direct-push-based, Geochemical Assessment of Natural Attenuation at a Former Underground Storage Tank Site

Marcia K. Schulmeister, Amelia L. Hess

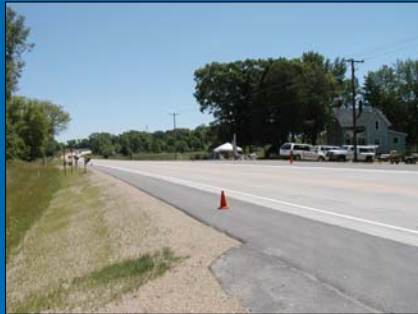
Site Conditions and Geology

- The LUST site examined is located on a strip of land between two lakes.
- The Site was closed in 2001 after excavation to depth of 10 ft. the source area and roughly 10 years of monitoring.

- In this view toward the east, the wetland/marsh/lake area can be seen in the south on the right side of the photo.
- The site is underlain by glacial sediments. Fine-grained materials (Silt, sandy silt and clay) are present in the upper 20 feet and grade laterally into sandy gravels to the east

- Below 20 ft, the aquifer consists primarily of coarse gravel
- Fine sands and silts beneath site are replaced with coarser materials near the surface at the north end of the site.

- One important features is the highway in the foreground. This road was replaced within the last few years and storm-water runoff system was modified. Runoff collects in the drainage ditch along the north side of the road and is diverted to the adjacent wetland.

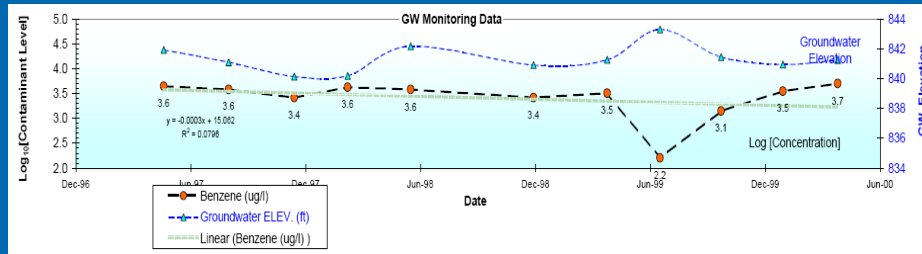
Historic Benzene Concentrations near Source Area

- A recent DNR analysis of several contaminants revealed that contaminant concentrations during the monitoring period remained relatively constant.
- In this example, fluctuations in benzene concentrations appear to be associated with changes in water levels.
- The persistence of benzene suggests that the source area may not have been completely excavated and that contaminated soil continues to impact groundwater.
- This investigation examined the role of natural attenuation in maintaining the contaminant plume

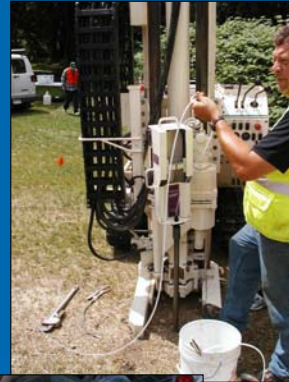
Sampling and Analytical Methods

- Direct-push geochemical profiler and mechanical bladder pump
- Samples obtained for field and laboratory analysis of inorganic and organic constituents at discrete depths
- Field analytical tools
 - Field Spectrophotometer
 - Multi-parameter sonde

- To identify natural attenuation processes, high-resolution sampling was conducted using the new direct-push based approach described in the last talk.
- Discrete-depth samples were obtained using a 12-inch, stainless steel screened sampler at multiple depths in a single probe hole
- A Mechanical bladder pump was used to obtain the samples
- DO, Fe+2, Mn, and SO4 concentrations were measured in the field prior to the collection of samples for additional lab analysis of organic contaminants.
